# Thermographic Anomalies in Roof Membranes: Wet Insulation or False Indications

Kathryn M. Barker

American Infrared Testing & Consulting, St. Petersburg, Florida 33733

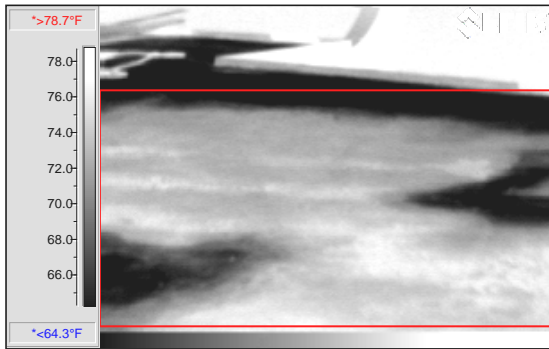
The most common roofing system in the industry is the Built-Up-Roof (BUR). It is a roof that is built with as many as three to five plies of roofing felts, adhered to each other with hot asphalt and capped with an asphaltic membrane and gravel ballast. The indications in Figures 1 and 2 are common to asphalt and gravel type BURs. Figure 1 displays an irregularly shaped anomaly referred to in ASTM C 1153 as “amorphous”. Figure 2 displays a combination of amorphous and poorly defined “board-stock” type anomalies.

**Figure 1. Amorphous anomaly on BUR**

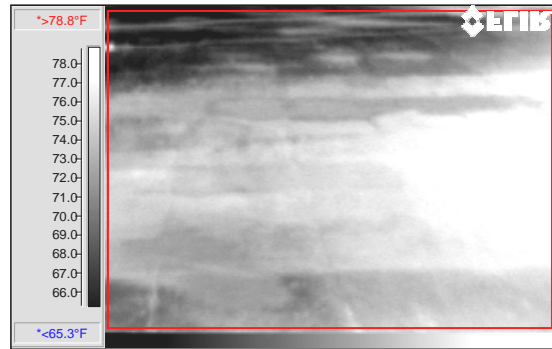
**Figure 2. Combination of anomalies**

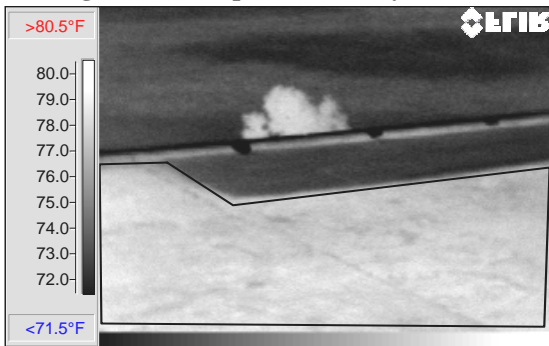
Figure 3 is a thermogram of a tar and gravel BUR. that was damaged during Hurricane Andrew. In this case, the roof was initially damaged by the storm and emergency repairs were made. Five years later the roof still had no follow-up repairs or restorations. All of the roof except for the initial repaired areas had deteriorated to the point that the only good spot on the roof was the dark “picture-frame” indication viewed in the middle of the image.

**Figure 3. Roof damaged by Hurricane “Andrew” with only the upper “dark frame” undamaged**

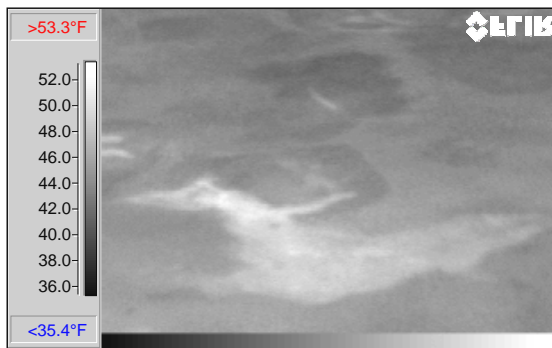
The SPF roof system can be identified thermographically by the apparent lack of detail on the surface of the roof. Everything looks blended together or somewhat smooth. Water intrusion indications in this kind of membrane are very irregular and stand out brightly. See figures 5, 6 & 7.

Figure 5. Water saturation pattern on SPF roof

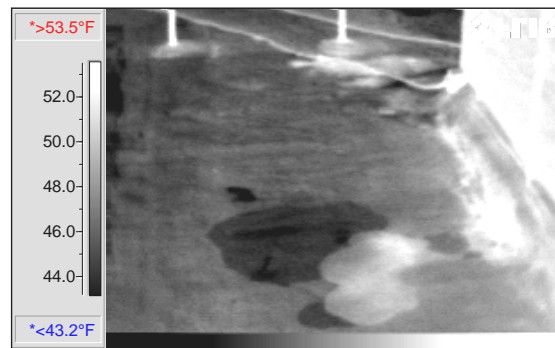
Figure 6. Water saturation pattern on SPF roof

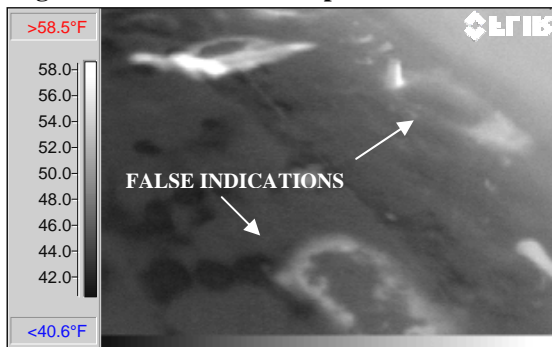
Figure 7. Real and false saturation indications

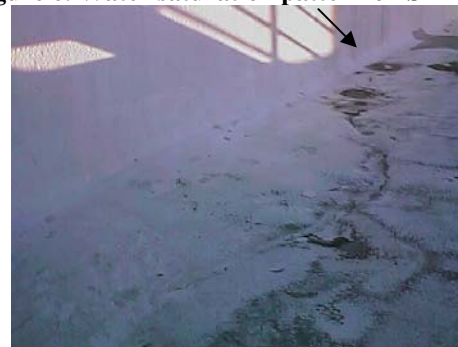
There are certain factors to keep in mind when surveying SPF roofs and caution must be exercised when identifying anomalies. The foam membrane is prone to damage from Ultraviolet breakdown, water encapsulation during installation, and normal wear from foot traffic. Birds also reek havoc on SPF roofs. They will peck at the membrane until an opening is produced. Certain species of birds will nest in the membrane. Another scenario that must be dealt with is small pockets of ponding water. Once water ponds an anomaly had begun. As the sun evaporates the pool, a breakdown of the topcoat starts. If this cycle is repeated over a season, the foam membrane will start to compact and trap dust, particles and leaves. Of course, this changes the emissivity of the surface of the roof and false calls can happen. See figure 8.

Figure 8. "False call" due to weatherization

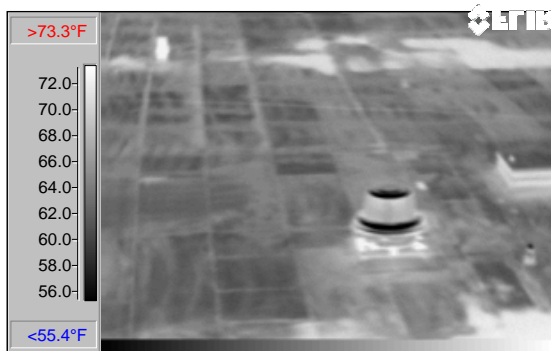
Shown below is a modified bitumen “torch down” roof.(Figures 11 and 12). Board-stock and amorphous anomalies are present . While this roof system was being installed, the edges of the individual sheets were over heated during the welded-seam process. The seams did not bind and water penetration was the end result.

**Figure 11. Water penetration anomalies on a “torch-down” roof caused by installation defects**

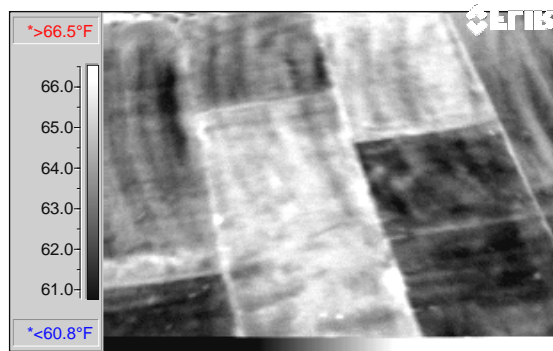
**Figure 12. Water penetration anomalies on a “torch-down” roof caused by installation defects**

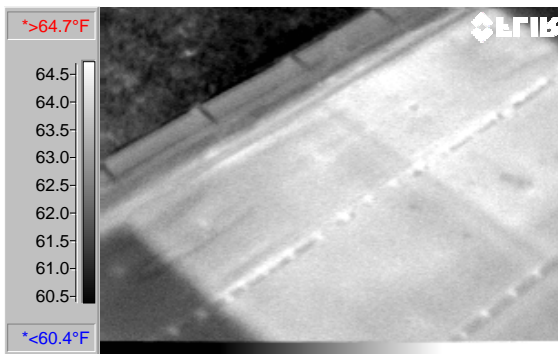
Figures 14 and 15 are an EPDM single-ply membrane that have a chemically adhered cap sheet over a nailable deck. The insulating material is a closed cell extruded polystyrene and is much like a brittle sponge. This is why the membrane looks wet but also appears to hold its original shape.

**Figure 14. EPDM single-ply membrane with a chemically adhered cap sheet over a nailable deck (closed-cell polystyrene insulation)**

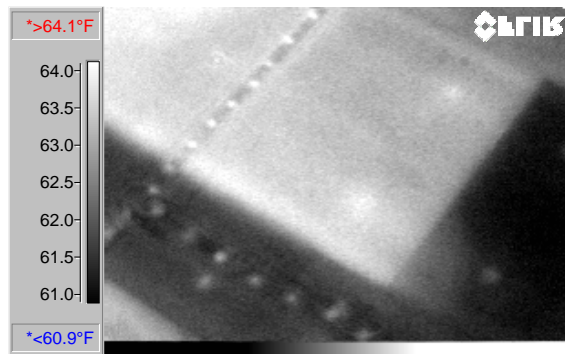
**Figure 15. EPDM single-ply membrane with a chemically adhered cap sheet over a nailable deck (closed-cell polystyrene insulation)**

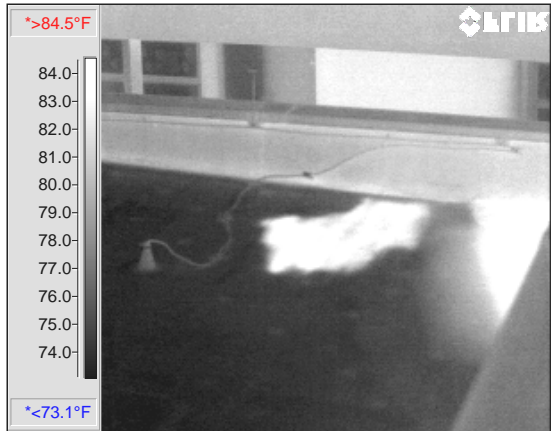
Figures 16 and 17 are also chemically adhered EPDM single-ply membrane however the insulating material is mineral-fiber board. The mineral fiberboard is the reason for the amorphous type indication versus the board type indications found in figures 14 and 15.

**Figure 16. EPDM single-ply membrane with a chemically adhered cap sheet (mineral fiberboard insulation)**

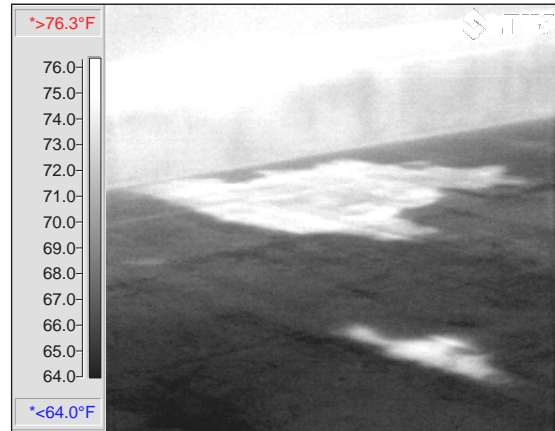
**Figure 17. EPDM single-ply membrane with a chemically adhered cap sheet (mineral fiberboard insulation)**

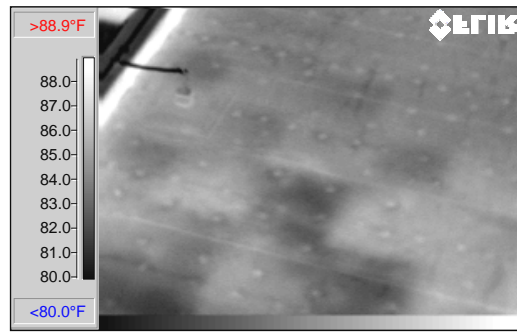
Figure 18 is also EPDM single-ply membrane fully adhered membrane only this membrane is mechanically fastened. The mechanical fasteners can readily be seen through out the thermographic image.

**Figure 18. . EPDM single-ply membrane system with the membrane mechanically-fastened**

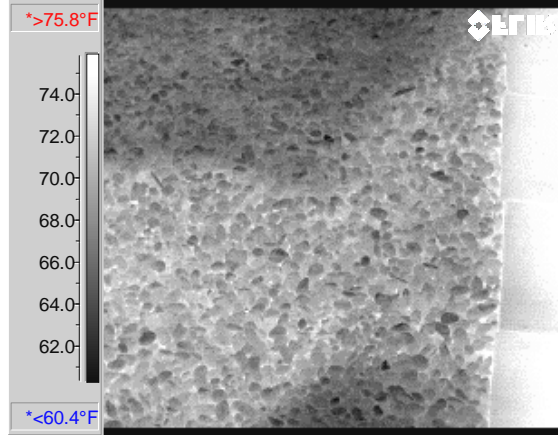
Figure 19 is a photograph of a partially exposed EPDM membrane. Figure 20 is a first view of a suspect anomaly and figure 21 is the same anomaly re-shot from an elevated vantage point. The author and the owner’s representative of this roof went to perform verification of the anomaly. To do this an invasive type moisture meter was used. When the membrane was punctured by the pins on the meter a small geyser developed. Special note should be made here. Never do invasive testing on a roof system without the roof manufacturer’s and/or owner’s permission. Any existing warranties left on the roof may be voided when you break the membrane. Also, be sure to repair any opening in the membrane created by the invasive test.

**Figure 20. first view of a suspect anomaly**

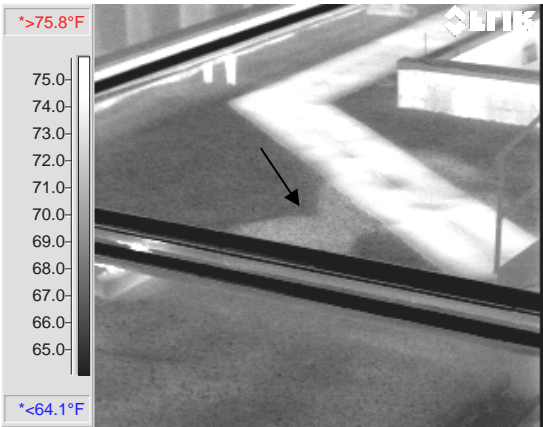
**Figure 21. Anomaly detected in Figure 20, seen from an elevated vantage point**
